GOES-17 Loop Heat Pipe Fact Sheet

Role of the Advanced Baseline Imager (ABI) Loop Heat Pipe

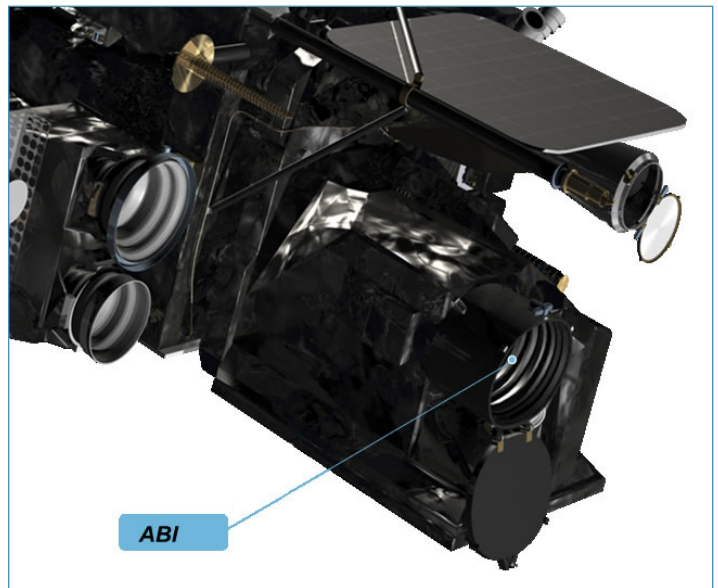
The ABI infrared detectors need to be cold to accurately measure thermal energy from Earth's atmosphere.
